**“BROOKFIELD DAM OPERATIONS STRAND, INJURE
ENDANGERED ATLANTIC SALMON”**

Field Summary of Atlantic Salmon Stranding Rescue at Lockwood Dam

Date: 6/15/2021

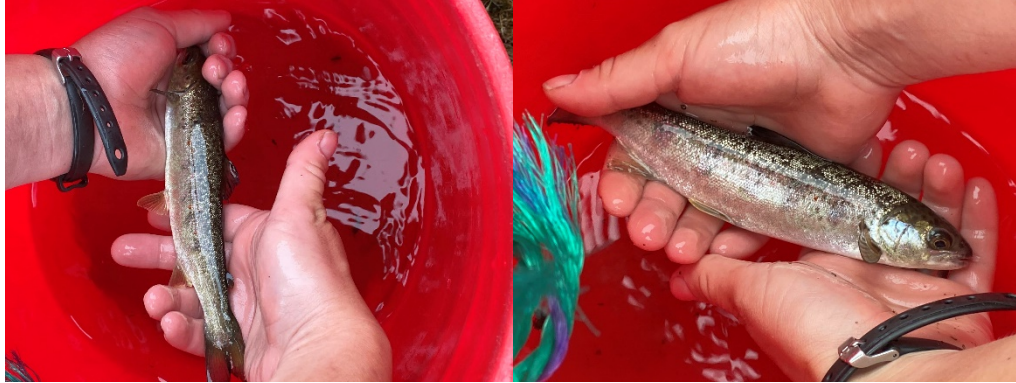
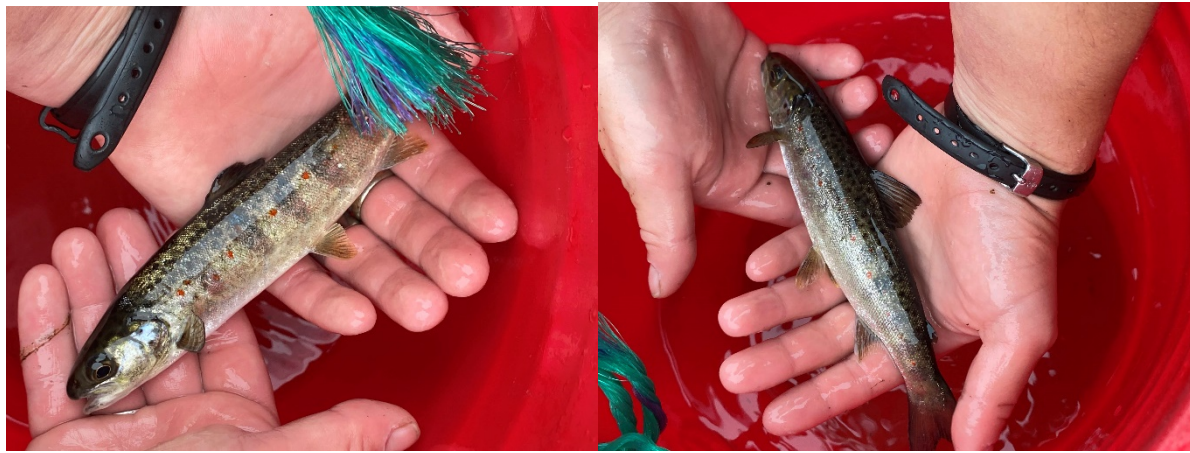
A DMR staff found approximately 10 smolts in one pool in the same area that the adult salmon was found. Staff then found 3 more smolts in another pool. Then approximately 10 in the large pool under the Rt. 100 bridge. Here are some pictures. They are most likely Atlantic salmon as they were very silvery and all a similar size.

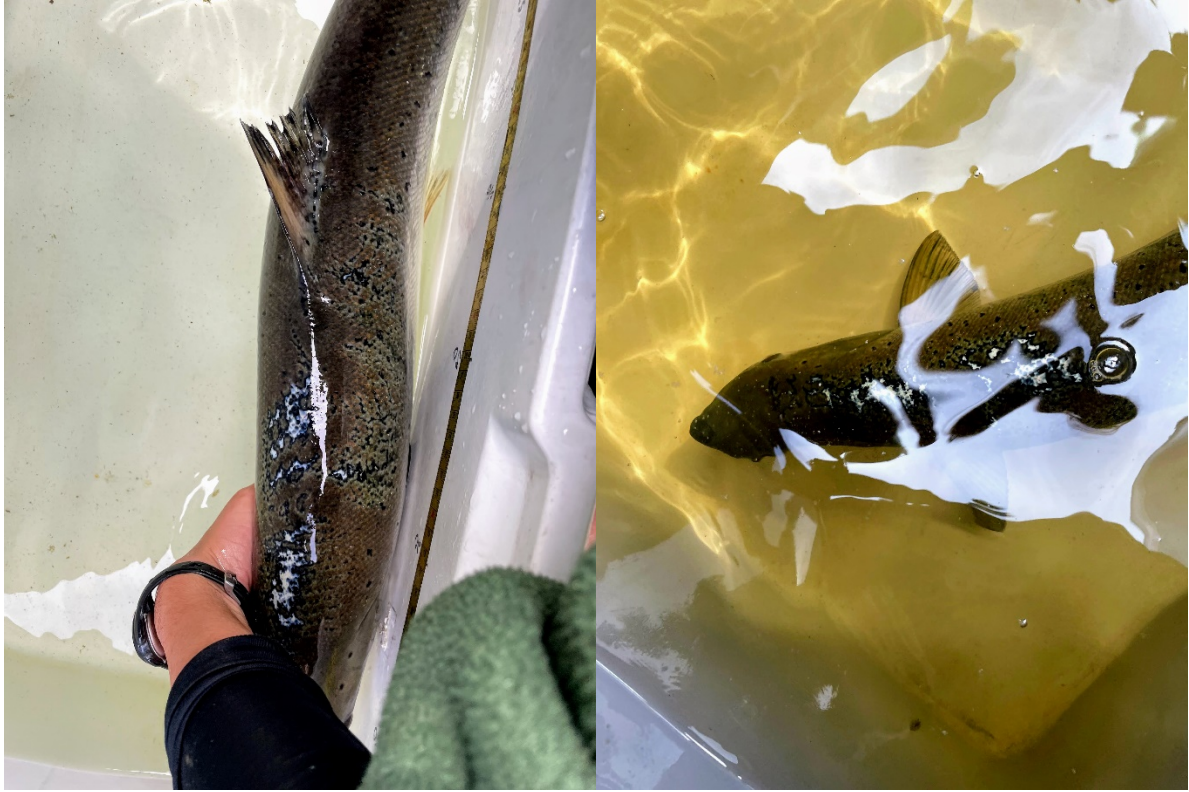
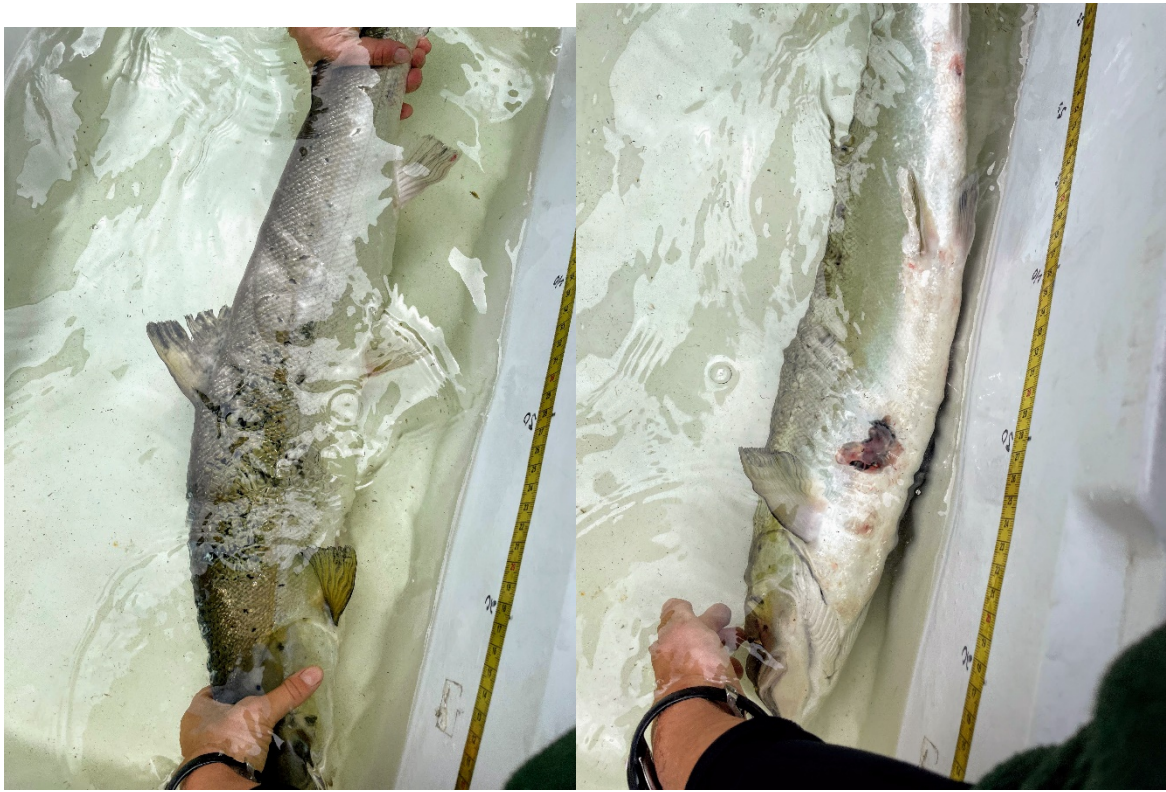
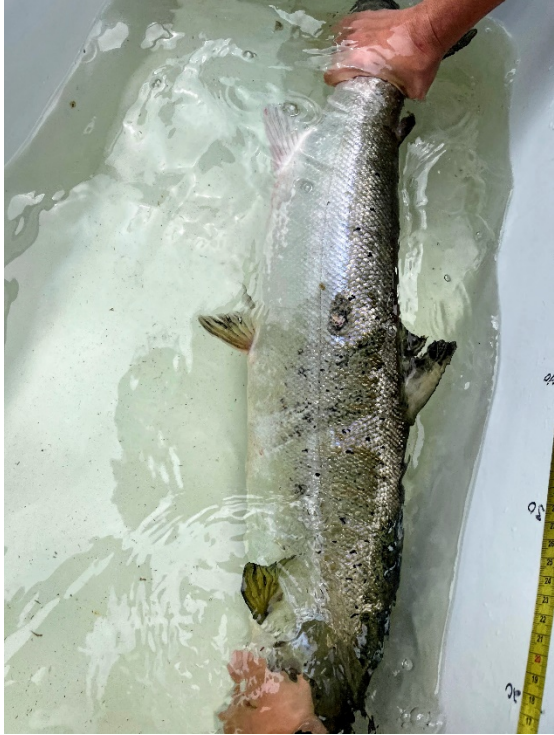
The one Atlantic salmon that was rescued from the ledges was brought upstream and released in the Sandy River at 4pm. It was a male that had a fork length of 73cm. The fish appeared to still be silver. It was noted to have brackish water lice, scraped up body dorsally, scraped up sides (both left and right), an abrasion ventrally, a bruise on its left side, a lamprey wound scar on its right side, a split dorsal fin, a split caudal fin and a bruised snout. See below. After reading the scales from this fish, it was a naturally reared 2 freshwater, 2 sea winter Atlantic salmon.

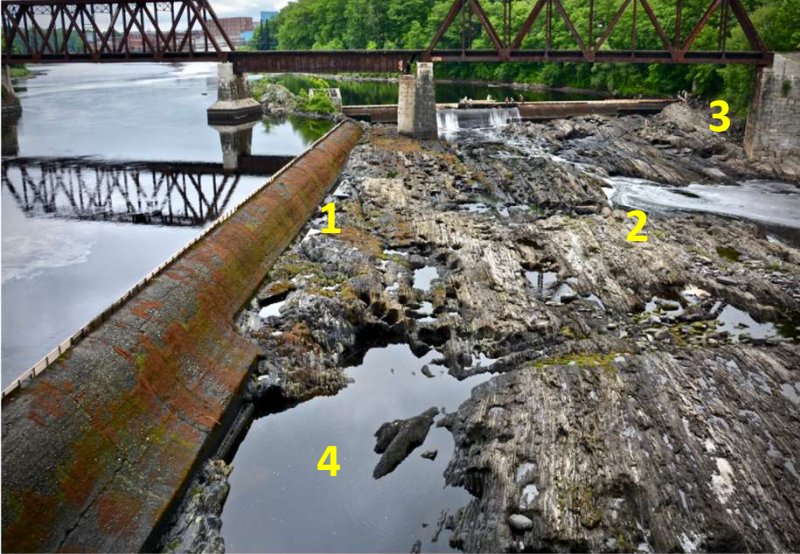
Salmon Rescue Locations (TT)

1. Appx. location of single rescued salmon.
2. Canoe transfer location.
3. Human chain over ledges to transport truck.
4. Isolated pool with at least 2 additional stranded salmon that could not be captured. One had obvious injuries and scars.

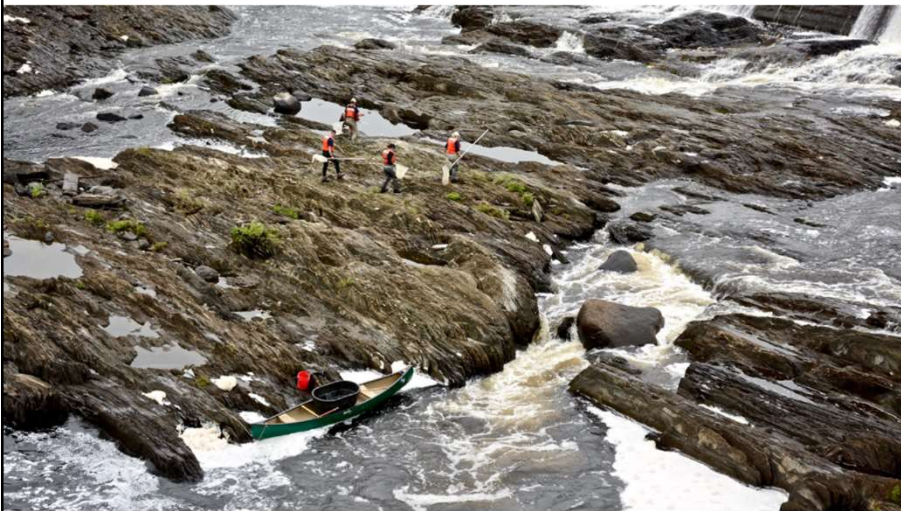
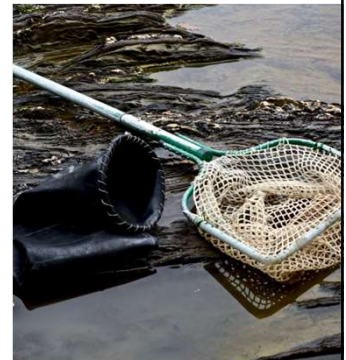
DMR crew deployed to search as ledges dewater. (TT)

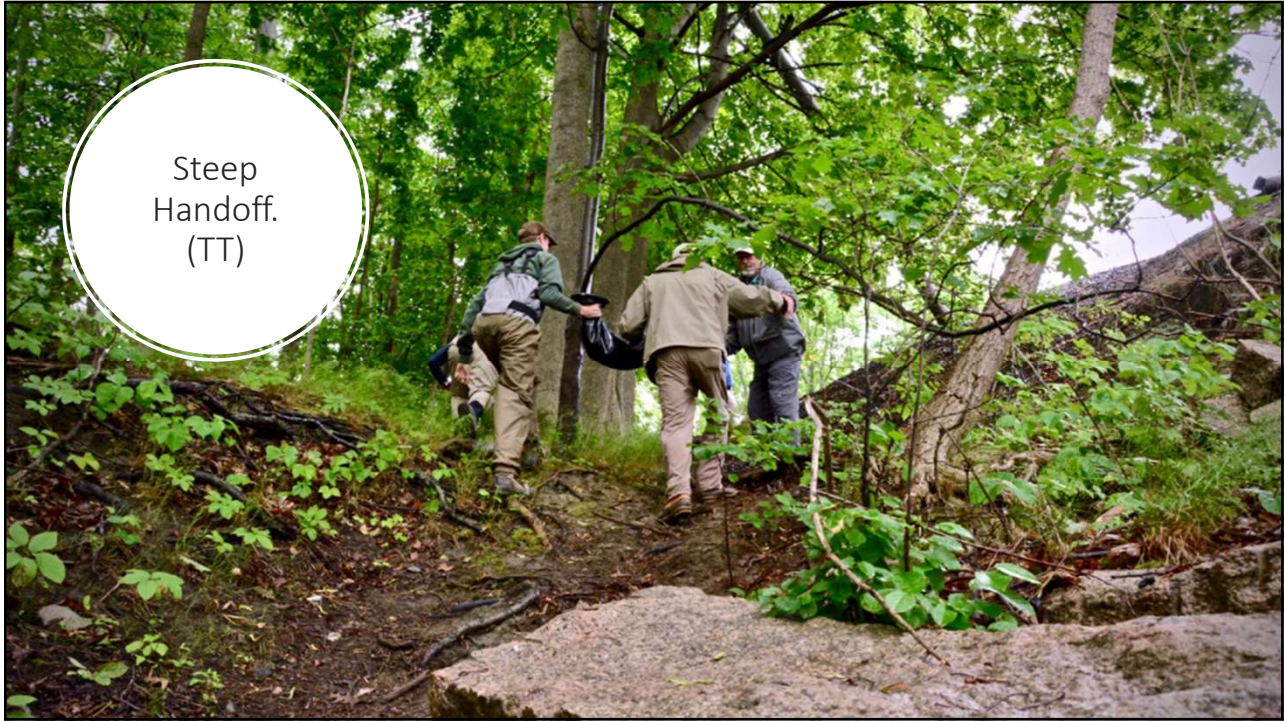
Steep
Handoff.
(TT)

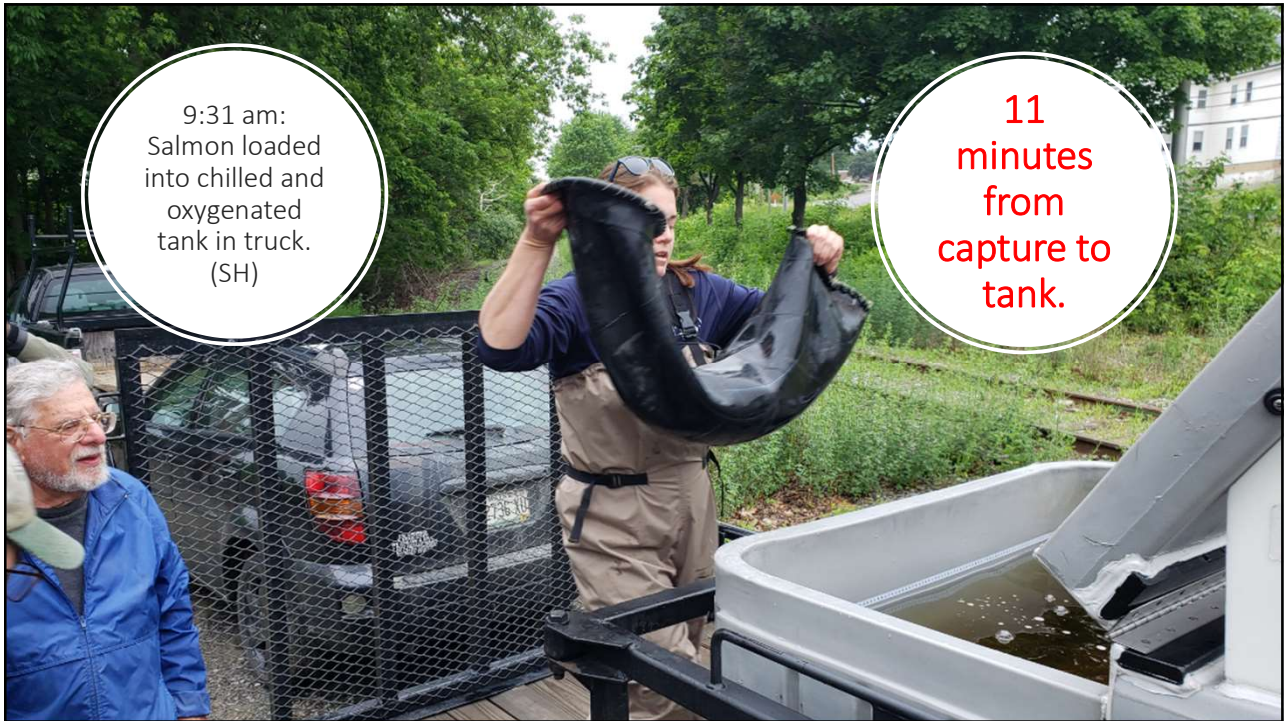
9:31 am:
Salmon loaded
into chilled and
oxygenated
tank in truck.
(SH)

11
minutes
from
capture to
tank.

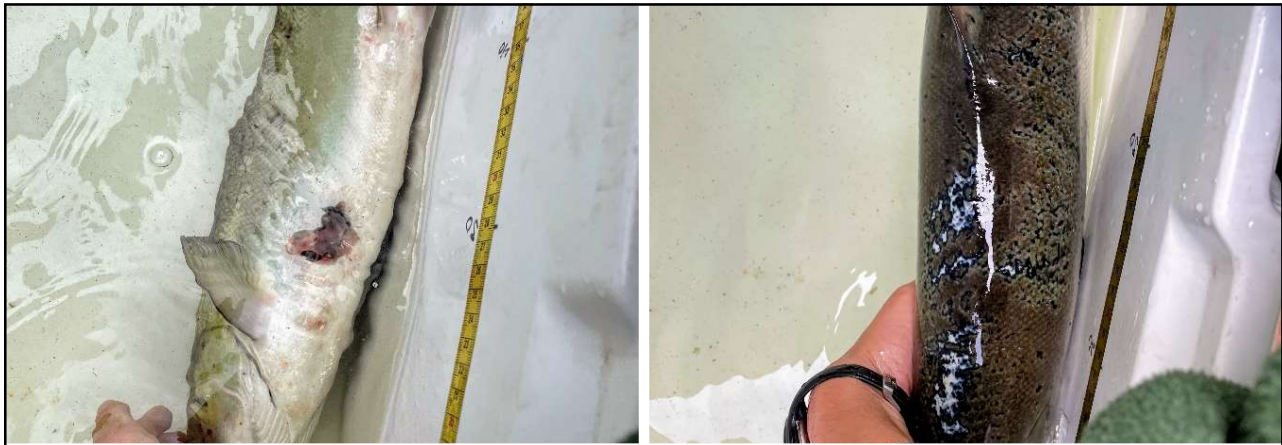
Injuries to captured salmon. “scraped up body dorsally, scraped up sides (both left and right), an abrasion ventrally, a bruise on it’s left side, a lamprey wound scar on its right side, a split dorsal fin, a split caudal fin and a bruised snout.” (DMR text and photos)

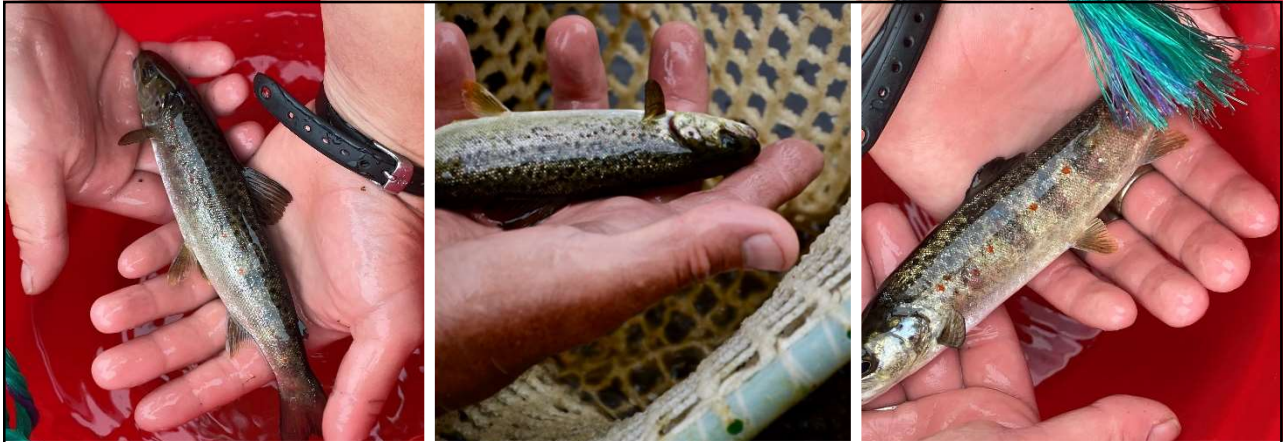
Nearly 2 dozen salmon smolts were also captured and relocated. (ME DMR and TT)
